CONSTRUCTION ENGINEERING RESEARCH LAB (ARMY) CHAMPAIGN IL F/G 13/11
DURABILITY AND FIRE-SPREAD ASPECTS OF PLASTIC PIPE SYSTEMS.(U)
JUL 79 A SMITH, R B WILLIAMSON

CERL-TR-M-264

TECHNICAL REPORT M-264
July 1979

DURABILITY AND FIRE-SPREAD ASPECTS
OF PLASTIC PIPE SYSTEMS

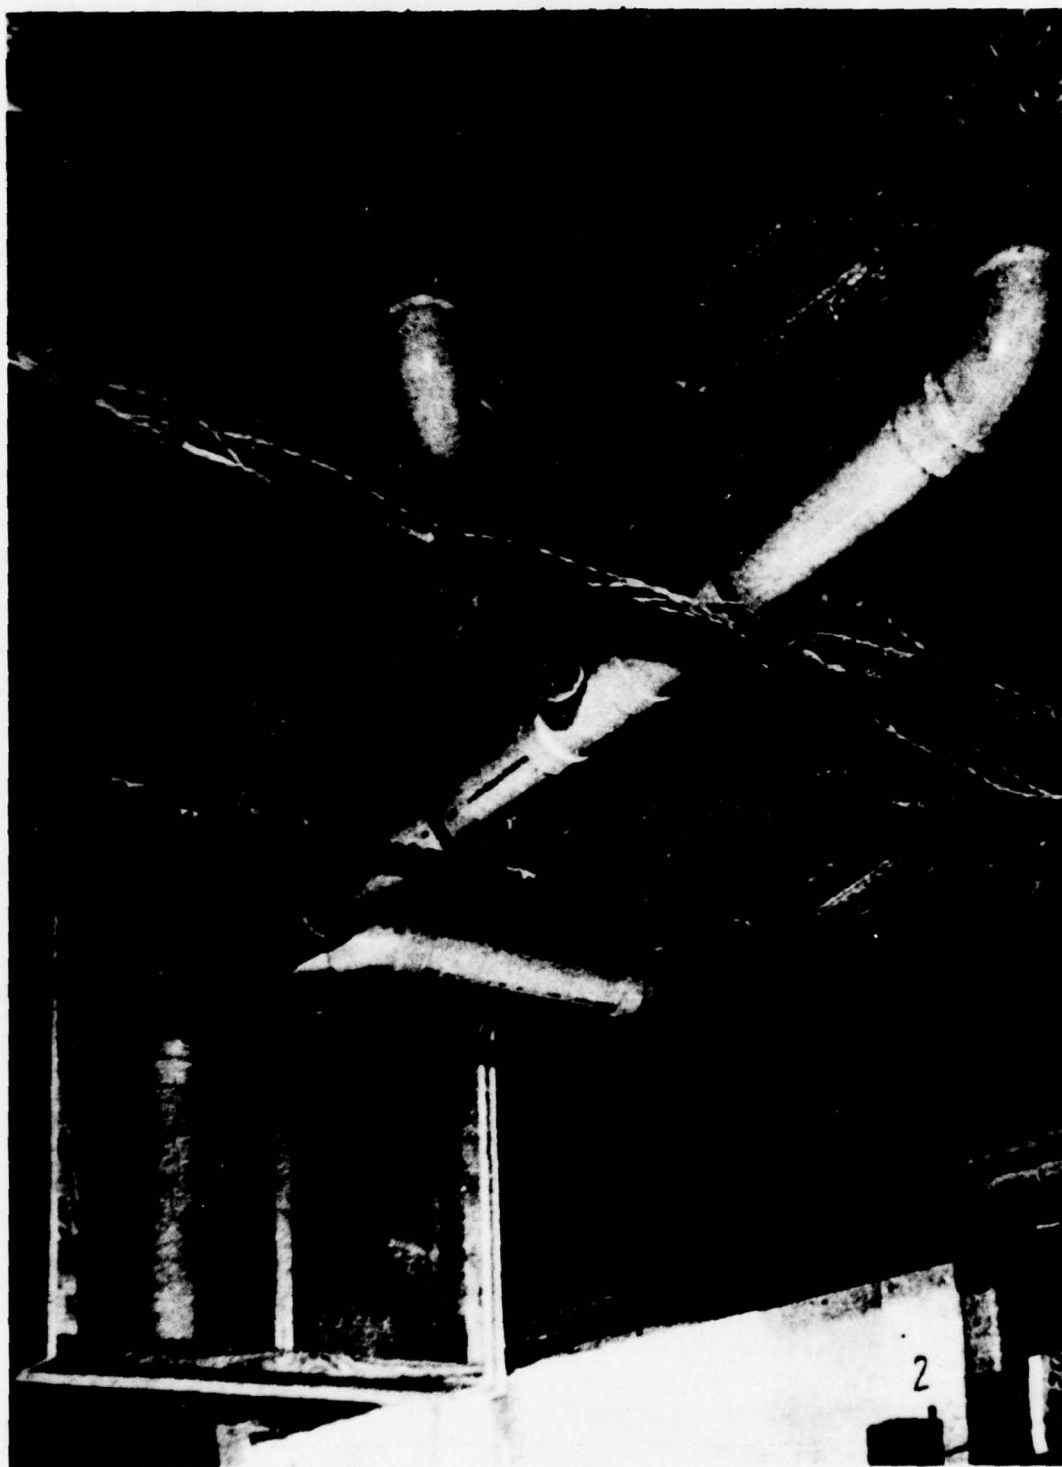
Figure A13. Photograph of the PVC plumbing run and stub wall before test. Note that the wallboard on one side of the stub wall was not yet in place.

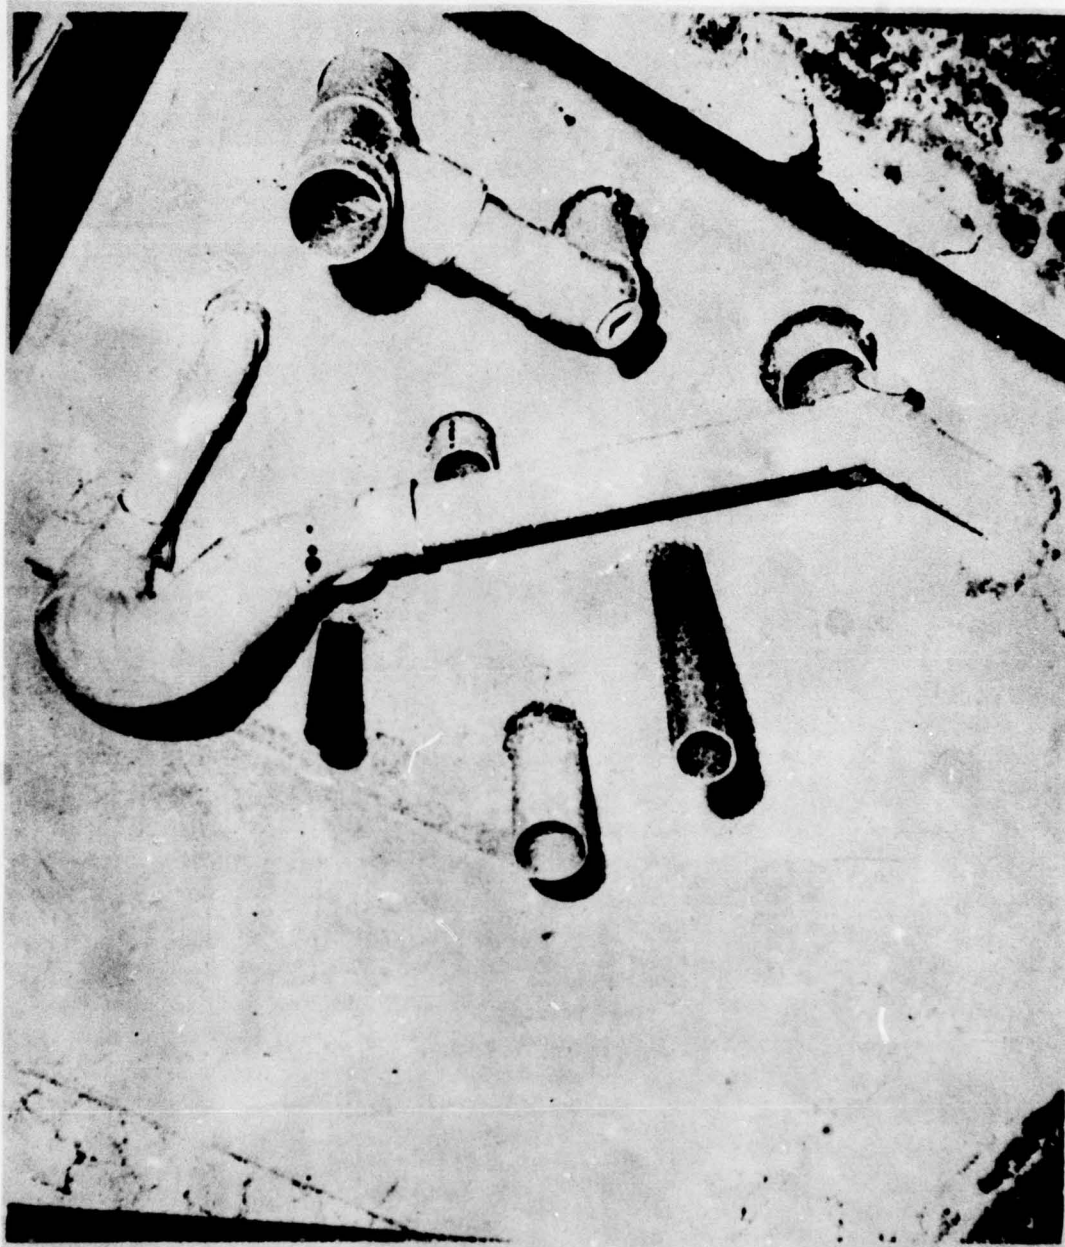
Figure A19. Photograph of the pipe and fitting below the floor slab in the Australian test on May 26, 1975. This is taken inside the furnace before the test.
